STEP STRESS TESTING PROGRAM

MSFC/NASA CONTRACT NUMBER
NAS8-31944

FINAL REPORT
FOR

JANTX 2N2905A

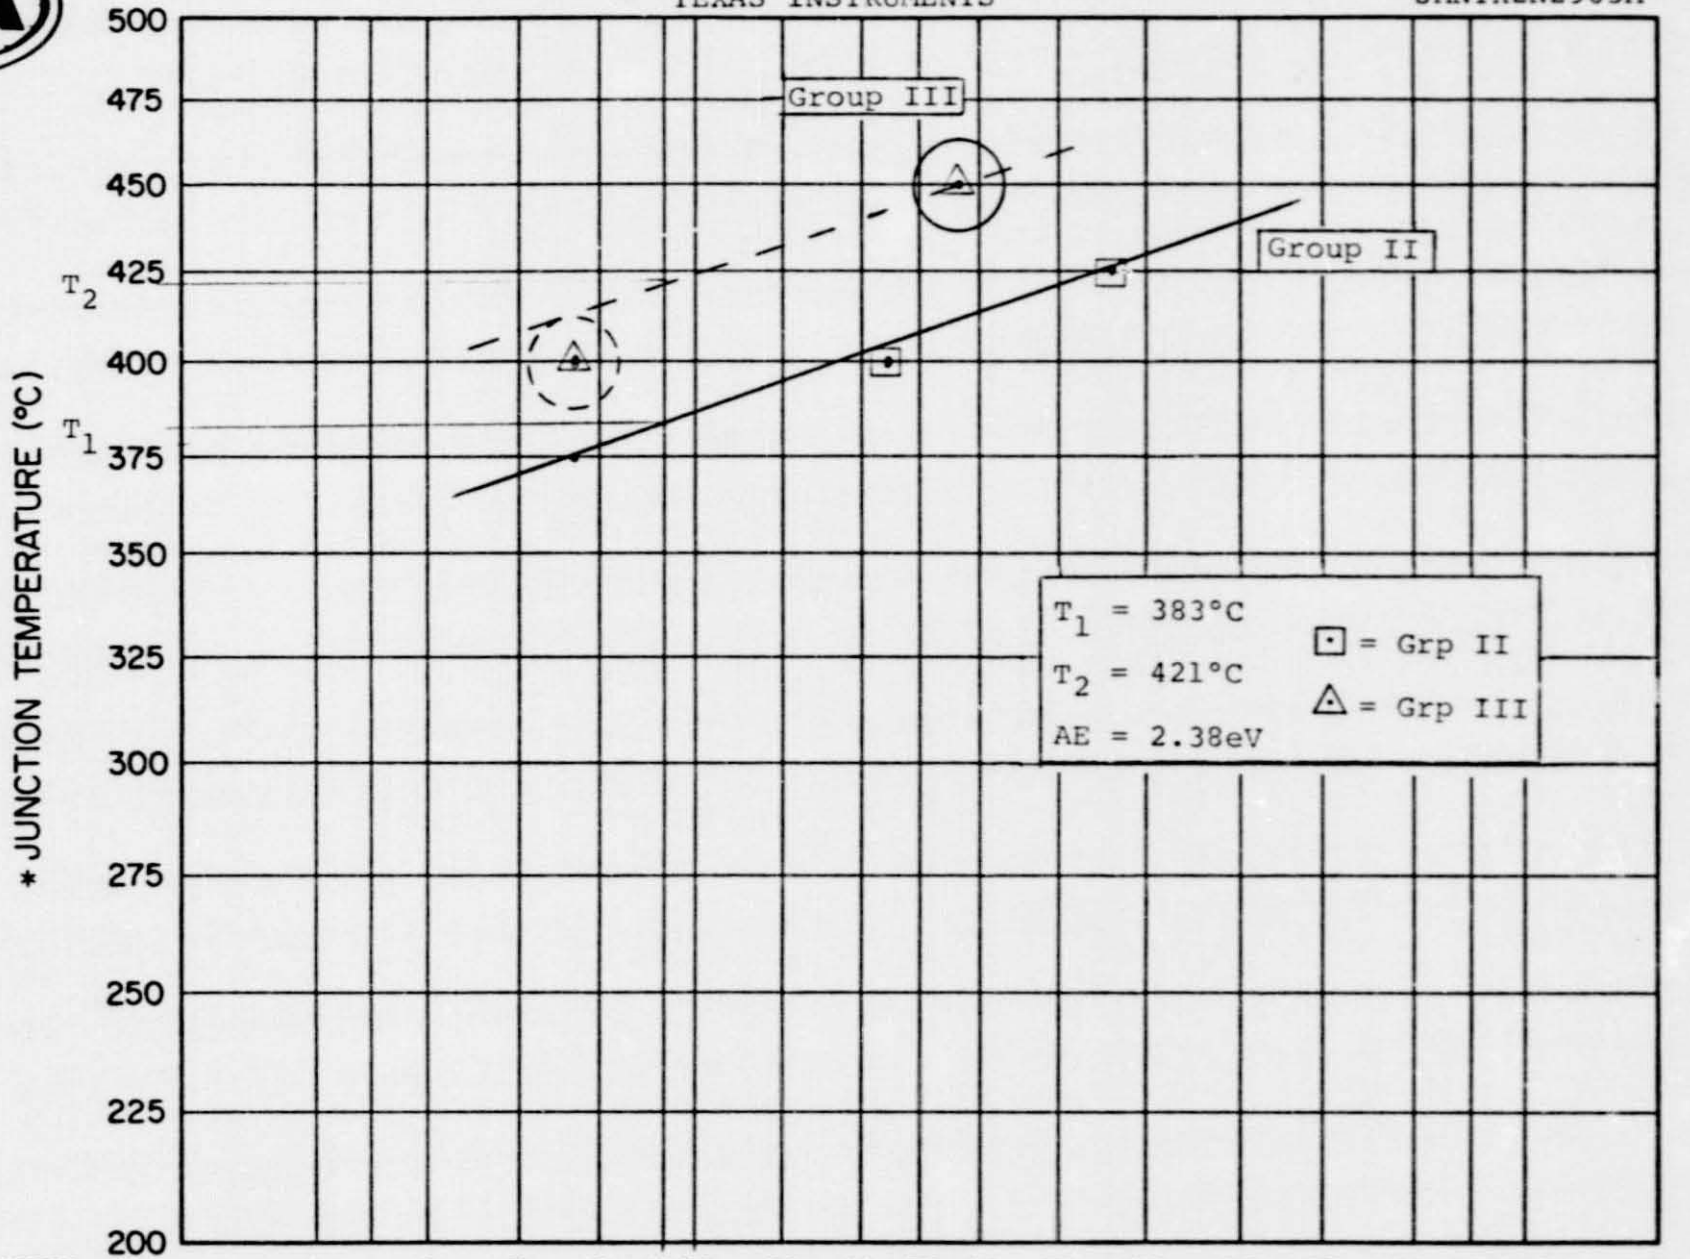
FIGURE 2
Cumulative Percent Failures Versus Junction Temperature, Texas Insturments

A plot showing cumulative failure distribution for Groups II and III was drawn for the Texas Instruments sample lot (Figures 2 and 3), but a complete plot for the Motorola sample lot could not be drawn due to an absence of failures in the Group III Testing. Figures 2 and 3 display the data for the Texas Instruments sample lot used to calculate an activation energy of 2.38eV.

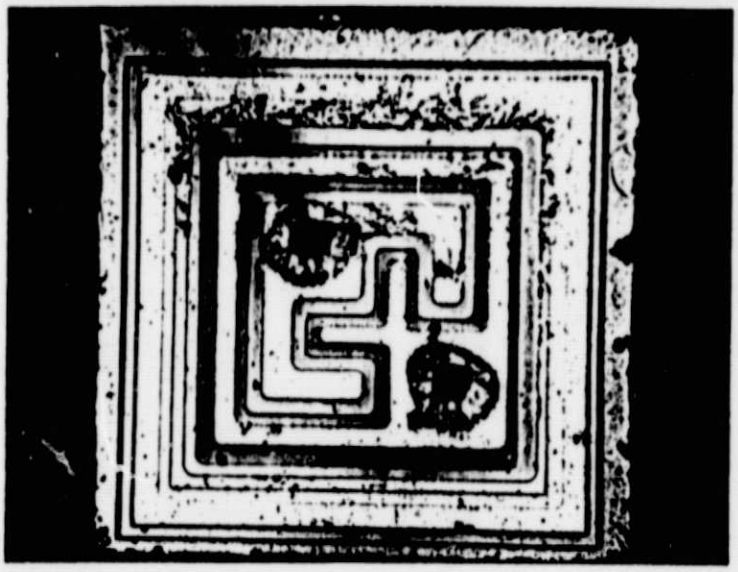
FIGURE A-1
S/N 4711, Texas Instruments Die Geometry, 144X.
(The dark areas in the metallization
are mechanically disturbed.)

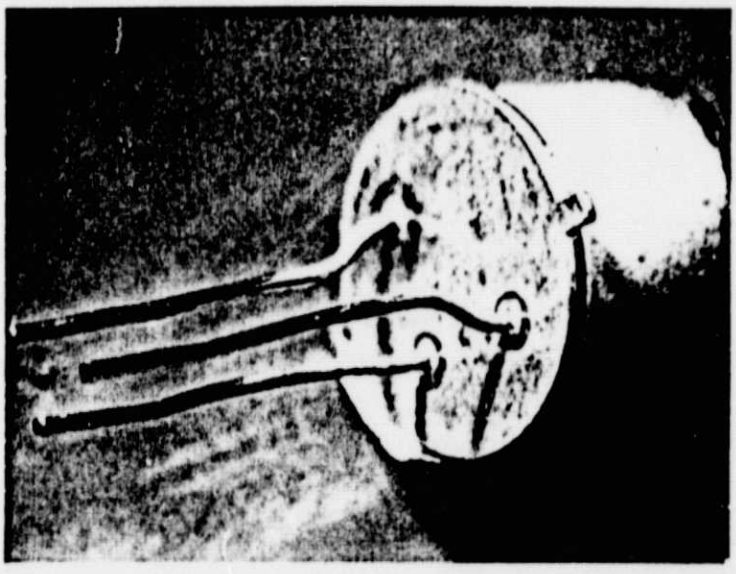
CONCLUSIONS: All the selected samples were functional and within acceptable limits. The only significant anomaly was the breaking off of the external wire leads. This breaking was caused by the use of close hole sockets on the burn-in boards. The leads had to be bent together for burn-in at each stage and then spread to normal separation for each test. These samples experienced from 25 to 35 cycles of bending and spreading before they broke. The main bending stress is concentrated where the leads exit from the glass of the header and all glass seals are somewhat cracked from this flexing (see Figure A-2).

FIGURE A-2
S/N 4760, Magnification 5X.
Typical lead bending for
insertion in burn-in board.

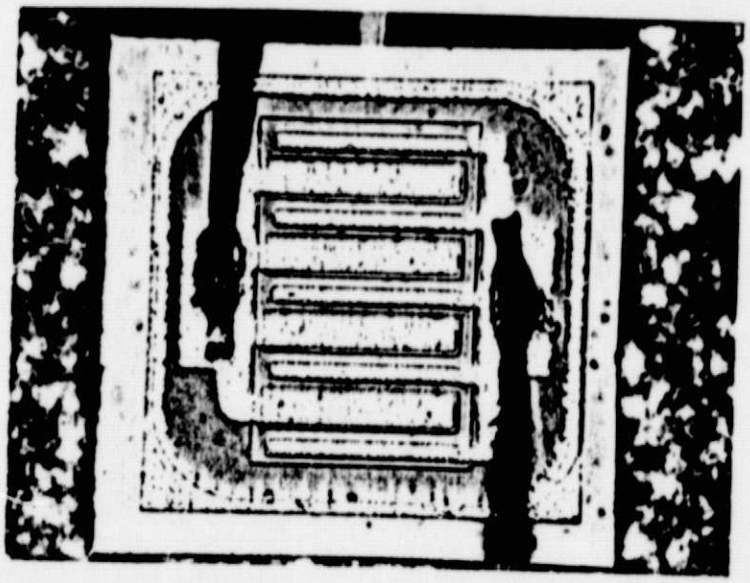
FIGURE A-3
S/N 4761, Typical Motorola Instruments
Die Geometry, 144X.

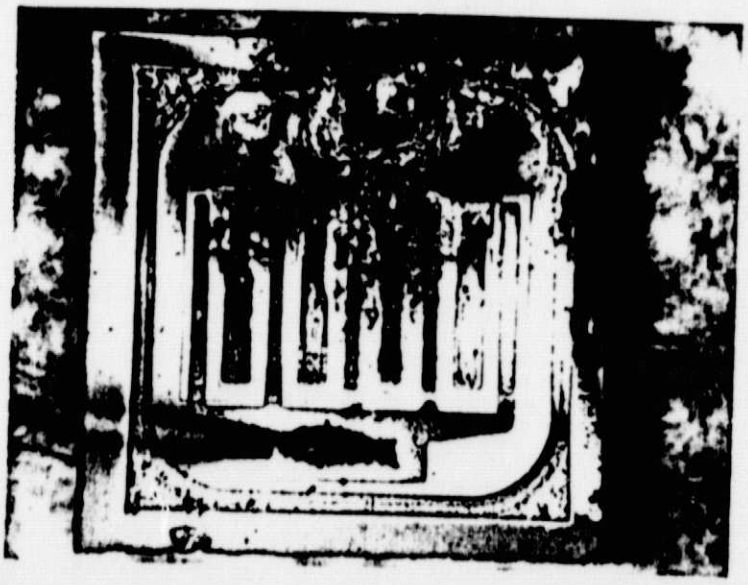
CONCLUSIONS: S/N 4769 was destroyed by high current operating over a long period of time. The emitter metallization and silicon were melted, as well as the internal gold emitter wire. (See Figure A-3.) The appearance of the damage suggests that the overstress current was greater than 2 amperes and flowed for longer than 100 microseconds. The voltage was not greater than the device breakdown of 30 to 75 volts. (S/N 4765 and 4767, which were not failure analyzed, also exhibited open emitters and are presumed to have the same failure mode as S/N 4769.) The source of the massive overstress is not known but the V_{SAT} tests suggest themselves as possibilities.

FIGURE A-4
S/N 4769, Motorola Device Destroyed
by Electrical Overstress, 144X.

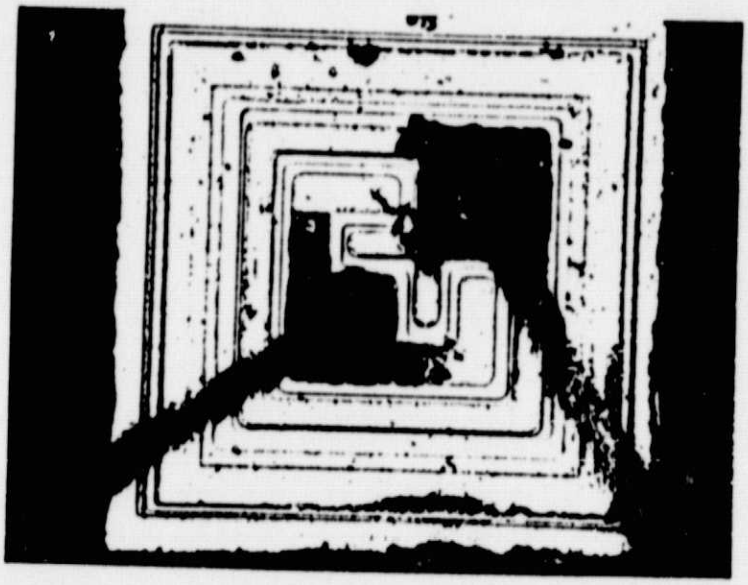
FIGURE B-1
S/N 4722, Typical Texas Instruments
Die Appearance, 160X.

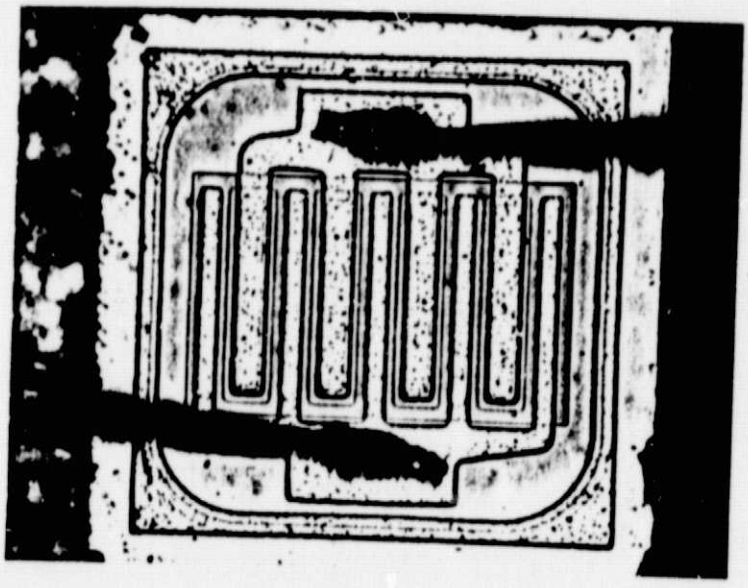
FIGURE B-2
S/N 4772, Typical Motorola
Die Geometry, 160X.

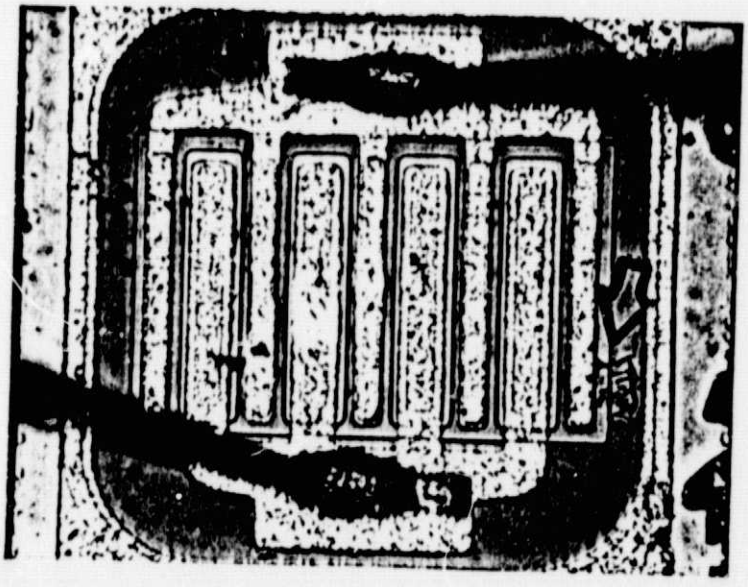
S/N 4784 exhibits silicon damage on the base-collector junction (see Figure B-3).

S/N 4787 There is a collector-base junction defect on this sample which breaks down at 70 volts. As the collector-base voltage is raised, a resistive trace appears on the curve tracer from 70 volts to the true breakdown at 104 volts. This defect is the cause of the excessive leakage for which the sample was rejected. See Figure B-3.

FIGURE B-3
S/N 4784, Motorola Sample, 200X.
Arrow indicates collector-base junction defect.

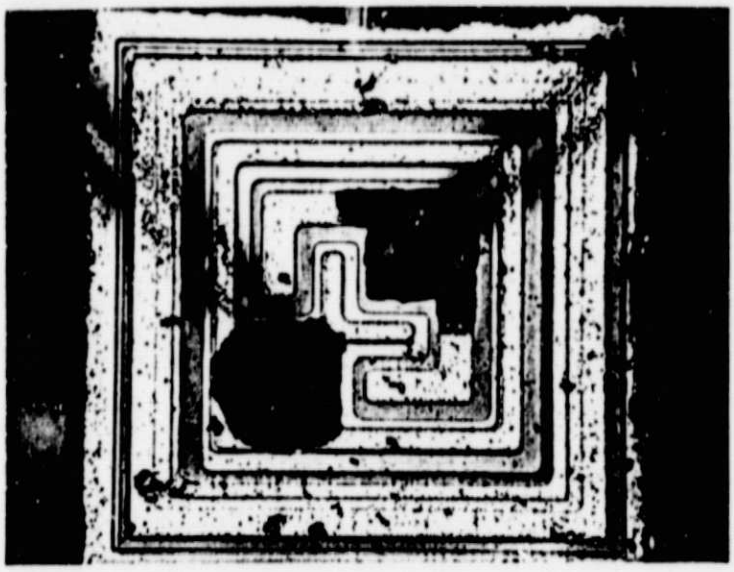
All samples have severe intermetallic formation surrounding the base and emitter lead wires. No other significant defects were visable (see Figure C-1).

These samples failed due to thermal overstress which caused gold/aluminum intermetallics to form, and which degraded the collector-base junctions. The excess die temperature and intermetallic attack upon the oxide allowed metallic impurities to contaminate the oxide and thus degrade the transistor characteristics. The emitter-base junctions did not degrade because the higher boron concentration of the emitter diffusions gettered the impurities at the emitter-base junction. Sample size - 5 ea. Failure Analysis - 5 ea.

FIGURE C-1
S/N 739, Typical Overall Die View, 152X.
Dark areas of gold/aluminum intermetallics surround the emitter and base ball bonds.

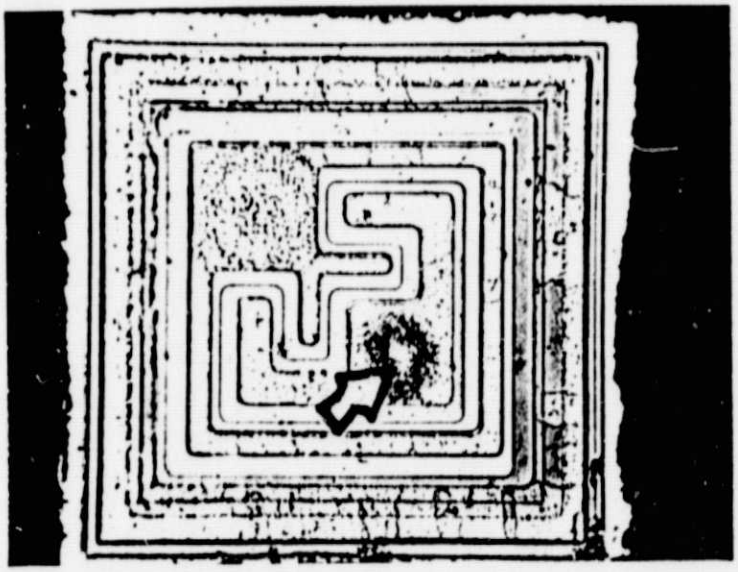
Upon stripping the metallization and lead wires chemically, areas of damage to the surrounding oxide could be seen under the former intermetallics (see Figure C-2).

FIGURE C-2
S/N 739, Same Die as Figure C-1, 152X.
After stripping the metallization and wire bonds.
Arrow indicates damaged oxide which was attacked by the intermetallics.
